Mamara New Capital City Development Phase 1 Environment Impact Statement (EIS)

Chapter 5: Geo-technical Engineering Assessment

Warwick Sitana August 2020

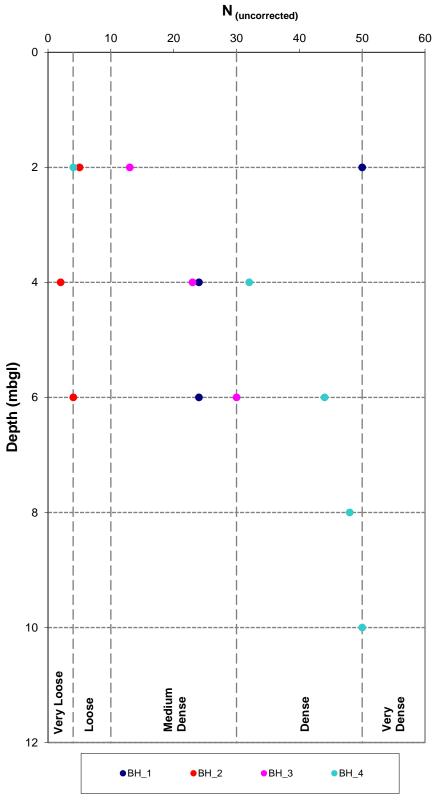
Figure 8.1 SPT-N, Depth-Density Summary.

SPT data show the Clay material as observed in BH2 to be soft. The SAND and Sandy GRAVEL is Medium Dense to Very Dense. The result of SPT exercise is summarised on Fig 7.1.

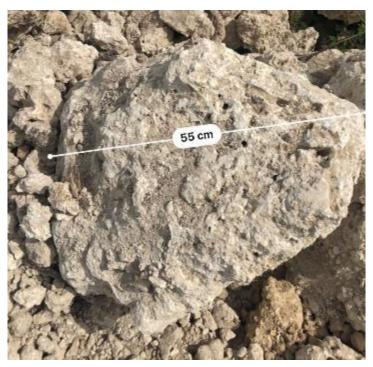
The materials observed at the spine road appear to have boulder sized grains as seen in Figure 8.1. Road base using corronous material should be crushed to granular sized material, i.e. 2mm to 200mm as described in New Zealand Geotechnical Society Soil and Rock Guidelines (NZGS Guidelines).

Figure 7.2 Boulder found on the Spine Road of the Development Area

Boulders are not recommended for road base material. It should be crushed to gravel sized material for durability and strength as large boulders do not interlock well. Crushing it to gravel sized material will allow for better interlocking between the different grain sizes as Average Least Dimension (ALD) of the granular material can be easily achieved during compaction.

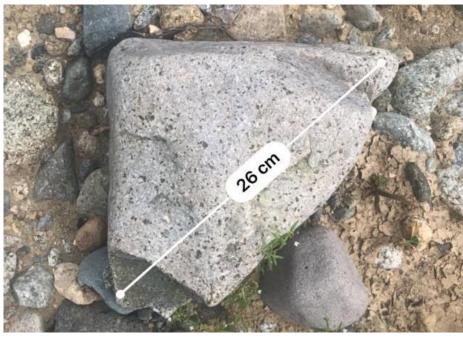
The Poha River aggregates are angular to sub-round as seen in the image below. The sizes vary from sandy to small boulders just greater than 200mm. Therefore, if these materials are considered to be used for the development, it is recommended they are tested for their suitability.

Figure 7.3 Poha River gravel and cobbles.

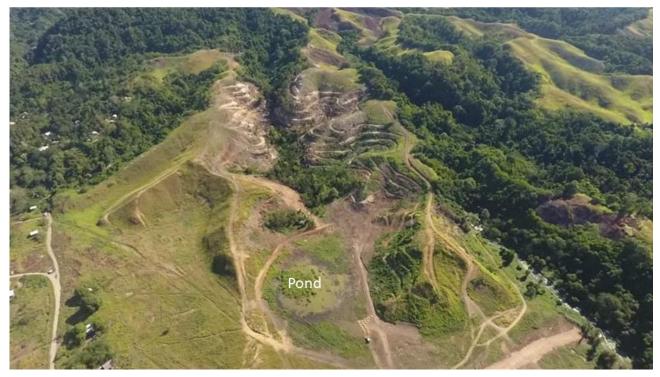
Evidence of earthworks and logging is observed on the slopes. This is marked by contour tracks on ridge flanks and remnant logs on the valley floor. Only the ridgelines and valleys within the immediate vicinity of the Mamara Spring are spared from logging activities.

Plate 4. View SW at logged ridges, Mamara River to the right, note pond in foreground.

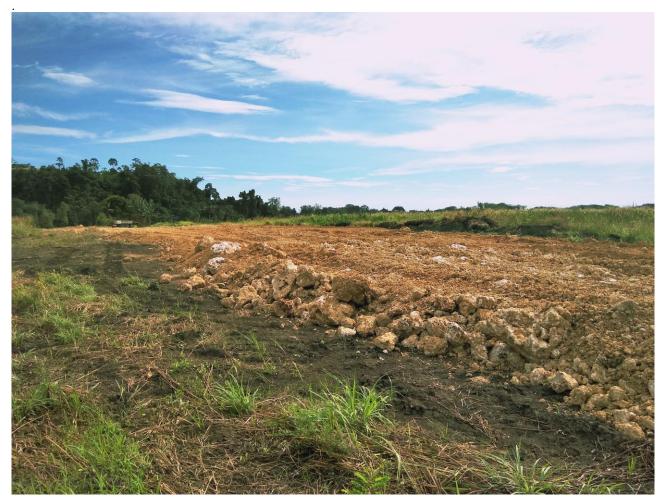
Plate 6. View along formed access, note courageous boulders used to construct road basecourse.

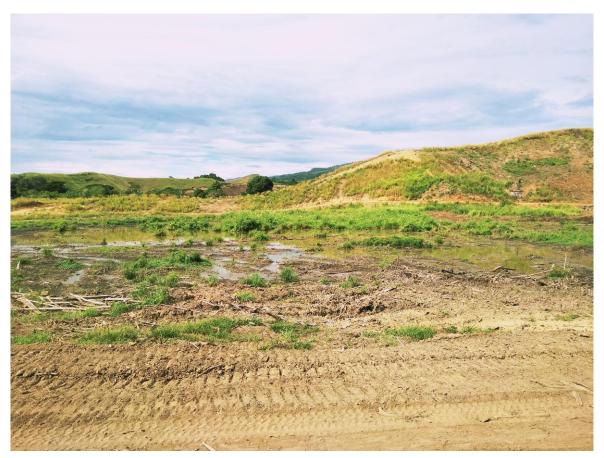
Plate 7. View at waterlogged area (pond).
