# Baseline assessment of water quality and aquatic ecology downstream of Gold Ridge Mine, Solomon Islands, February 2016

**School of Civil Engineering**

## Executive summary

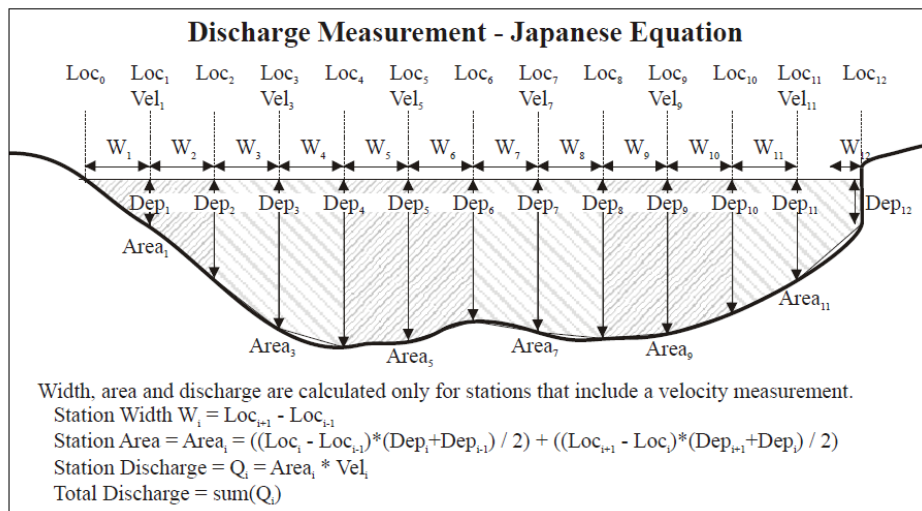
Figure 6: Equations used to calculate stream discharge

At each site a cross river profile was conducted using a Leica Disto 410 laser distance meter and measuring staff. At each 1 m interval a time averaged (40 seconds) assessment of water speed at mid-water column was taken using a Sontek Flowtracker. The cross sectional surface area and current speed was then calculated following the “Japanese” method and a velocity co-efficient of 0.85 to account for reduced flows over the coarse bottom of these streams (Figure 6).

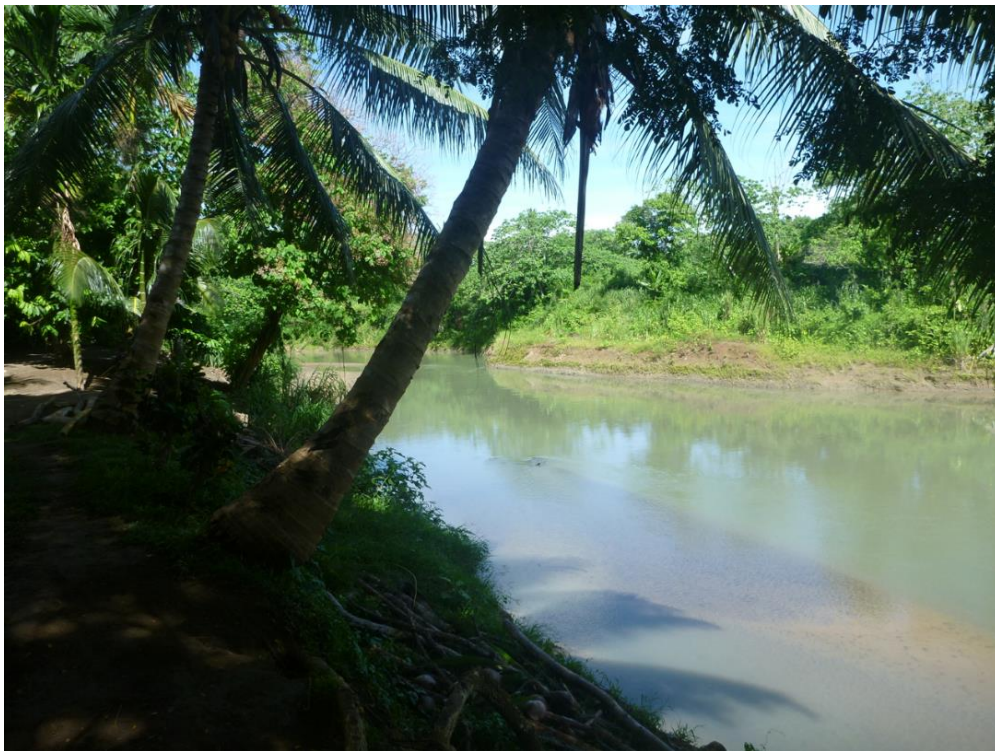
Figure 8: View of Metapona River from timelapse camera installed at SIG 14

These point measurements provide a useful snapshot of flow conditions, longer term flow sampling was undertaken at a single key site, SIG14, to better understand the nature of flow events. A timelapse camera was placed on the stream bank facing the water surface collecting an image every 4 hours for approximately 8 months prior to this sampling event (Figure 8). Using the relatively height of the streambank it is possible to observe the frequency and relative magnitude of flow events at this key site.

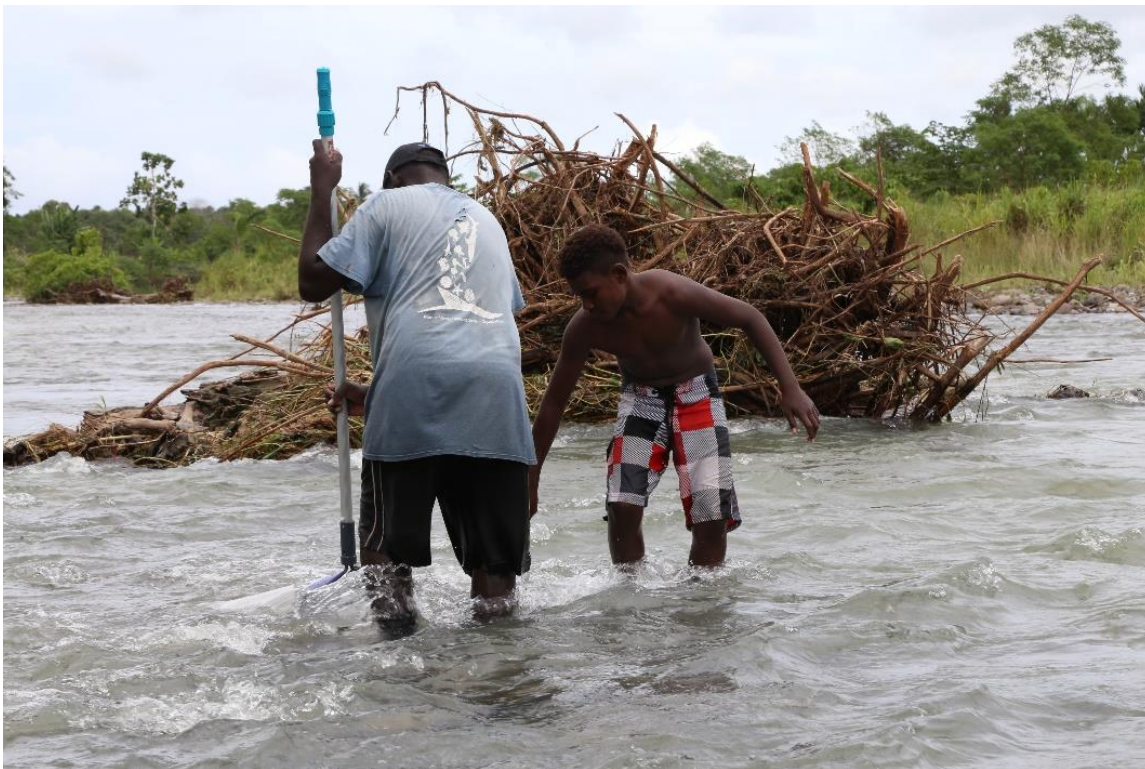
Figure 9: Sampling macroinvertebrates in Tinahulu River

*Quantitative and Qualitative assessment* – five replicate samples were collected from each site using a kick-net (mesh 0.3 mm) within the range of habitats at each site. This included slow flowing edge habitats for taxa that prefer these conditions (e.g., snails and damselflies), 10m edge length (5m on each edge) pools,

and ripples. Macroinvertebrates were collected by placing the kick-net downstream of water flow and the habitat disturbed by standardised kicking methodology to dislodge aquatic organisms to be washed downstream and collected in the rectangular kick-net. At some sites with overhanging vegetation or within slow pools and the tailing dam, a kick nets was scooped under the vegetation on the river edges or side of the pool to collect macroinvertebrates in a method more appropriate for collecting additional invertebrates that would be missed by kick sampling alone.

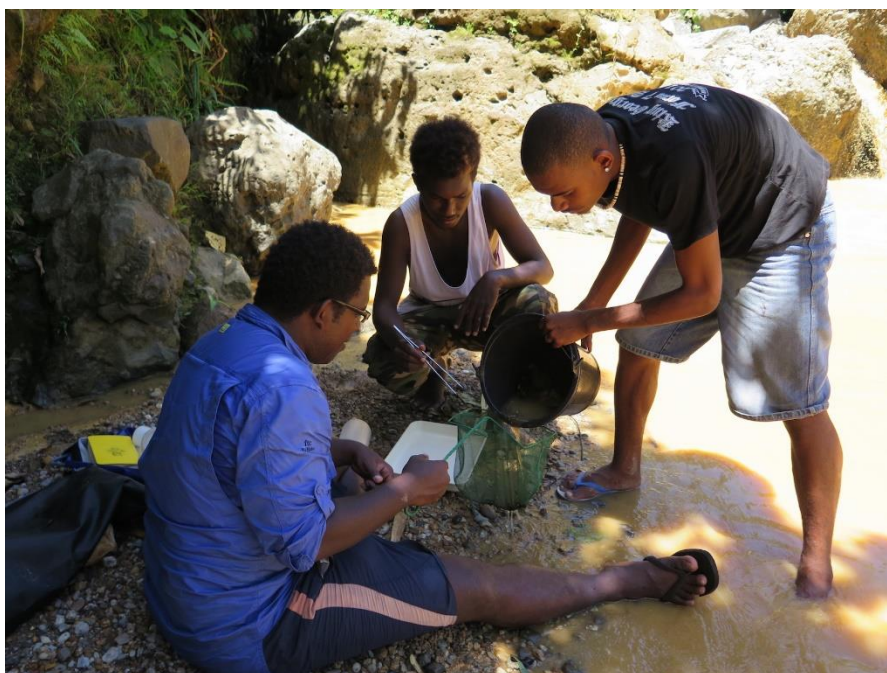
Figure 10: Sorting of aquatic macroinvertebrate samples

Macroinvertebrate samples were preserved in 75% ethanol prior to identification by a NATA certified laboratory in Australia (Ecoscope Environmental).

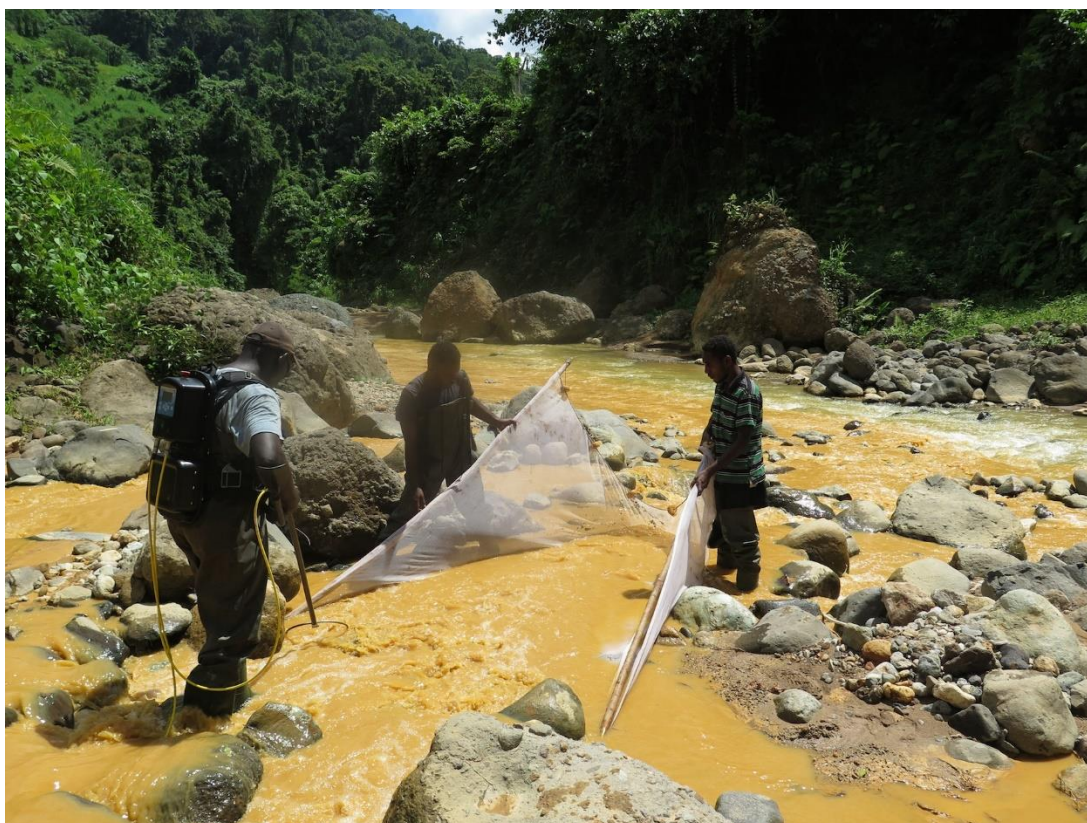
Figure 11: Electrofishing in Charivunga River at SIG0

A portable electro-fisher (Model No: E-Fish 500W) was used for sampling of fish. The electric fishing machine was powered by a 12-volt battery that gives an output of 200 W, frequency of 100Hz or 150 Hz and a duty cycle of 50%. Electric fishing was performed in wadeable streams by progressing in an upstream direction to keep the water in front of the operators clear. The electric fishing survey was concentrated on fast ripples and river edges with vegetation's hanging over the streams. The fishing electrode created an electric field within a radius of a one-meter zone under average condition. When fish come in contact with the electric field it is stunned and can be caught easily with a hand net. Electric fishing was conducted in most sites except for TSF sites and River sites with very high turbidity (SIG 3, SIG 4, SIG 5, SIG 6, SIG 15 and SIG 16). A seine net (50 mm X 2500mm x 1200 mm) was used to collect fish at Site SIG 16. Fish that could be identified in the field were counted and then released alive back into the stream, whereas fish that required further identification were collected and stored in 75% ethanol while in the field. The following references Keith et al 2010 and Keith et al 2015 were used for fish identification and species confirmation.

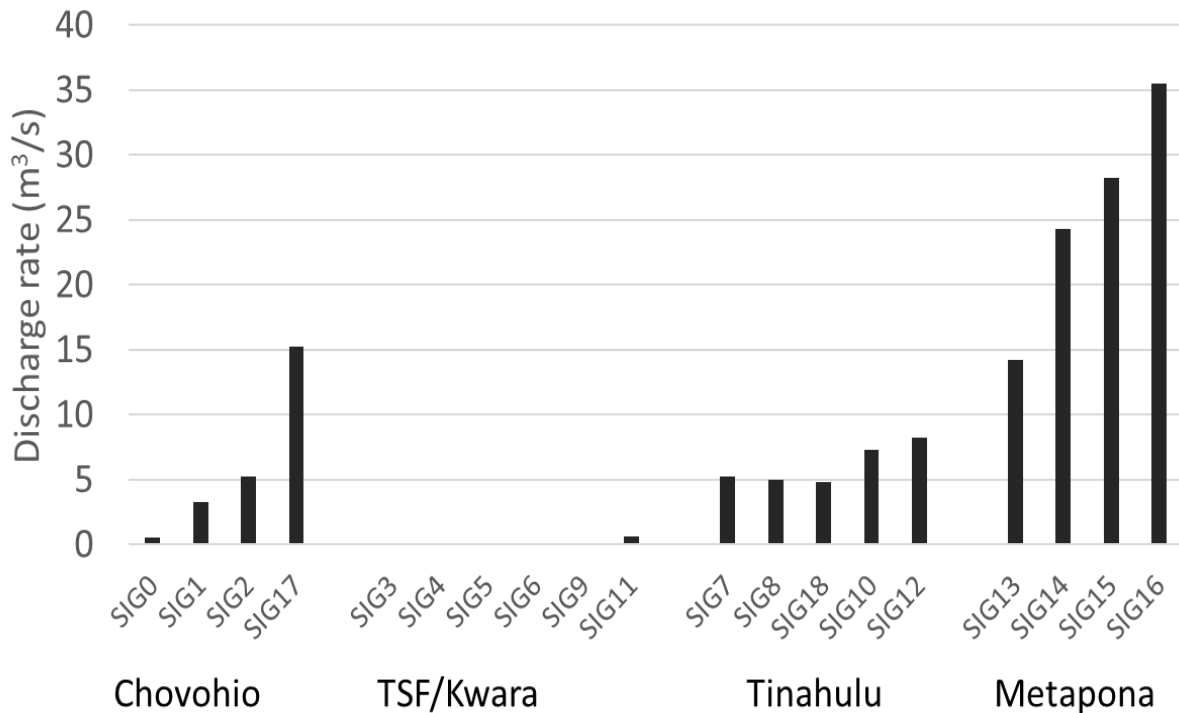
Figure 15: Discharge rate of rivers

The discharge rates of each section of river varies considerably, with the Chovohio providing the highest contribution (15.2 m<sup>3</sup>/s at SIG17) to the Metapoana system. The Tinahulu had a discharge of 4.9 m<sup>3</sup>/s at the TSF discharge point below the brige and 8.2 m<sup>3</sup>/s at SIG 12 prior to confluence with Chovohio. The Kwara River had a discharge of only 0.6 m<sup>3</sup>/s at SIG 11 prior to its confluence with Tinahulu making it particularly susceptible to any large increases in discharge from overtopping of the TSF spillway. The Metapoana River discharge ranged from 14.2 m<sup>3</sup>/s in the mid-Metapoana at SIG13 to 28.2 m<sup>3</sup>/s at the river mouth at SIG 16 (Figure 15). These discharges in February 2016 could be considered typical for February and are slightly lower than the mean for February in 2011 from GRML data (Table 10).

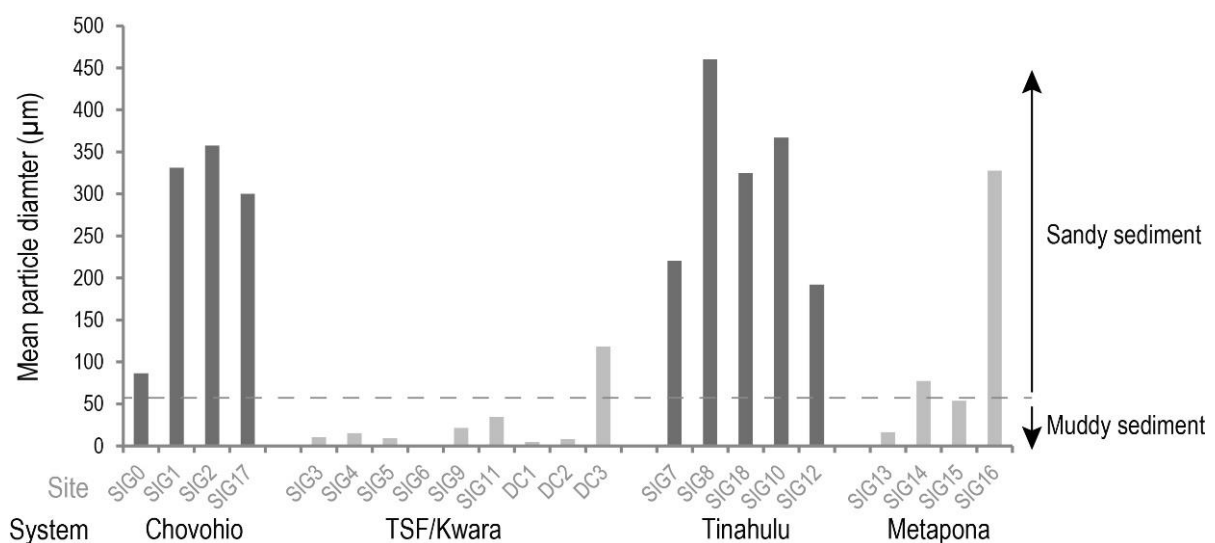
Figure 17: Mean particle size of riverbed sediments

The lower Metapona River sediments contained relatively small particles and high mud content with the exception of the river mouth site (SIG16). It is likely the highly dynamic nature of water flow at this particular site, with wave energy, tidal and river inflow currents, results in continual resuspension of smaller sediment particles. Evidence to support this is the relatively high water column turbidity values found at this site.

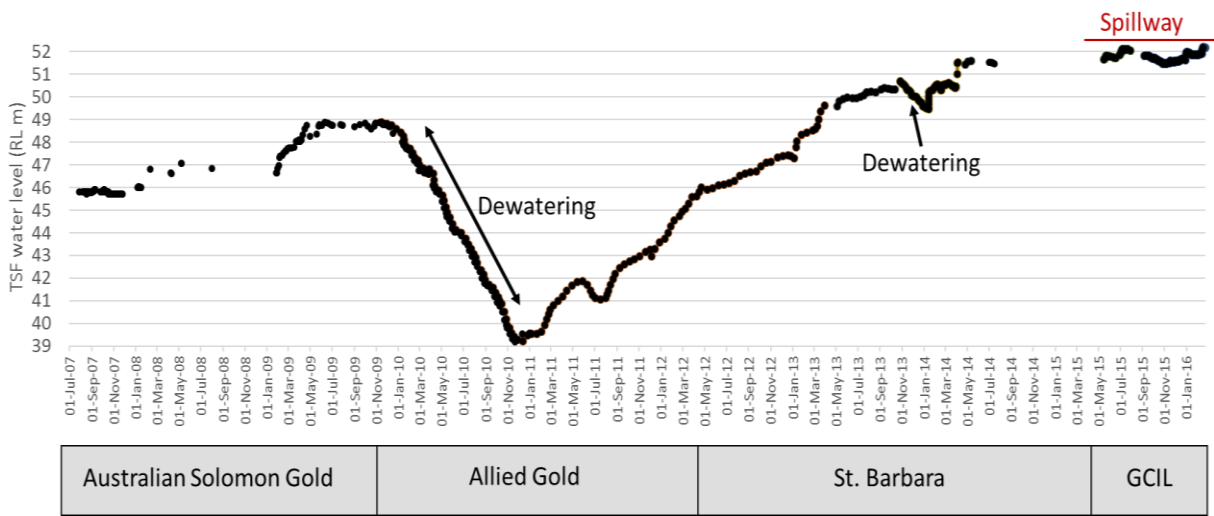
Figure 18: Water level in Tailings Storage Facility from July 2007 to February 2016 with ownership of Gold Ridge Mine over time indicated below graph

The high water level within the Gold Ridge Tailings Storage Facility has been one of the key drivers of concern for the Solomon Islands Government, downstream communities and international agencies. The drivers of water level within the TSF are a complex interaction between mine operations (tailings input, return water re-use), hydrology (rainfall, evaporation, seepage, catchment run-off), TSF volume (tailings sediment level) and dewatering. Whilst the mine was non-operational between 2000 and 2009 there was a steady increase in the TSF water level due to rainfall. In 2010, prior to mining operations starting, a dewatering program was conducted to lower the TSF water level down to 39 m RL. During the 2011-2013 period the mine was operating with significant volume of tailings introduced into the TSF, this combined with rainfall led to a rapid increase in TSF water levels to over 50 m RL. To compound these high water levels a series of low pressure systems and cyclones in 2013 delivered significant volumes of rainfall to the TSF catchment. In response to this a treated dewatering process was initiated in late 2013 and water levels were briefly dropped below 50 m RL (Figure 18). However, an unprecedented rainfall event of  $>1000 \text{ mm}$  of rain in 4 days in early April 2014 led to a series of events including the company abandoning the management of TSF, and a rise in water levels to over 51 m RL and eventual sale of Gold Ridge Mining Limited to a local landowner company (GCIL). Whilst the April 2014 rainfall was the trigger for these events and the current state of critically high TSF water levels, the underlying drivers are related to the significant volume of tailings introduced to TSF from 2011-2014, the lack of dewatering and minimal re-use of supernatant between 2011-2013, and the failure to raise the main TSF embankment in sync with the lost dam volume due to tailings output (as per original design). Following heavy rain in February 2016 the water level within the TSF reached 52.189 m RL, less than 20 mm from the lowest point on spillway (Figure 19). Whilst there has been no overflow of TSF waters over spillway to date, treated dewatering of the TSF waters will be required in the

short-term to prevent an uncontrolled release of TSF water over the spillway into Kwara River. Whilst dewatering represents an important short-term solution, medium to long term consideration should be given to either raising the main embankment or decommissioning and rehabilitation of the dam.

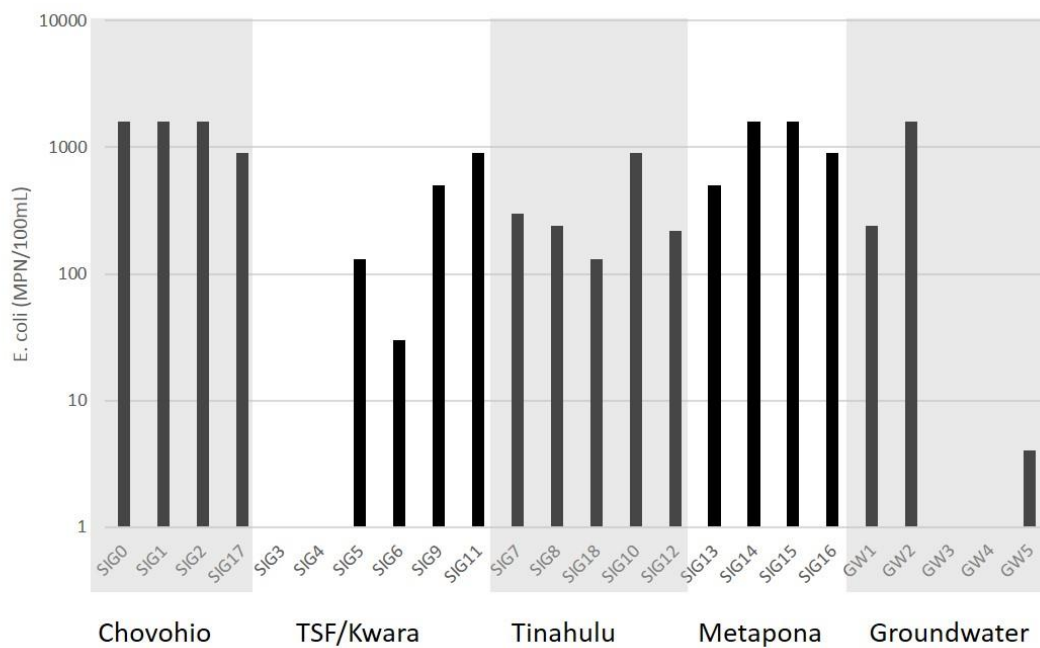
Figure 21: E.coli (cells per 100 ml) in river and groundwater samples

Concentrations of E. coli cells were high (>100 cells per 100 ml) across all riverine sites. Two of the shallow groundwater wells (GW1 and GW2) also had relatively high concentrations of E. coli (Figure 21). However, the holding time between collection of samples and laboratory analysis was >48 hrs for the majority of samples and is likely to have resulted in an overestimation of cell counts.
